BIOLOGICAL STREAM SURVEY

**ROCKLAND COUNTY, NEW YORK
LOTIC SCENE INVESTIGATION (LSI)
2016 STREAM BIOMONITORING WATER QUALITY PROJECT**

PREPARED BY
WATERSHED ASSESSMENT ASSOCIATES, LLC
SCHENECTADY, NEW YORK

FOR
ROCKLAND COUNTY SOIL AND WATER CONSERVATION DISTRICT
POMONA, NEW YORK

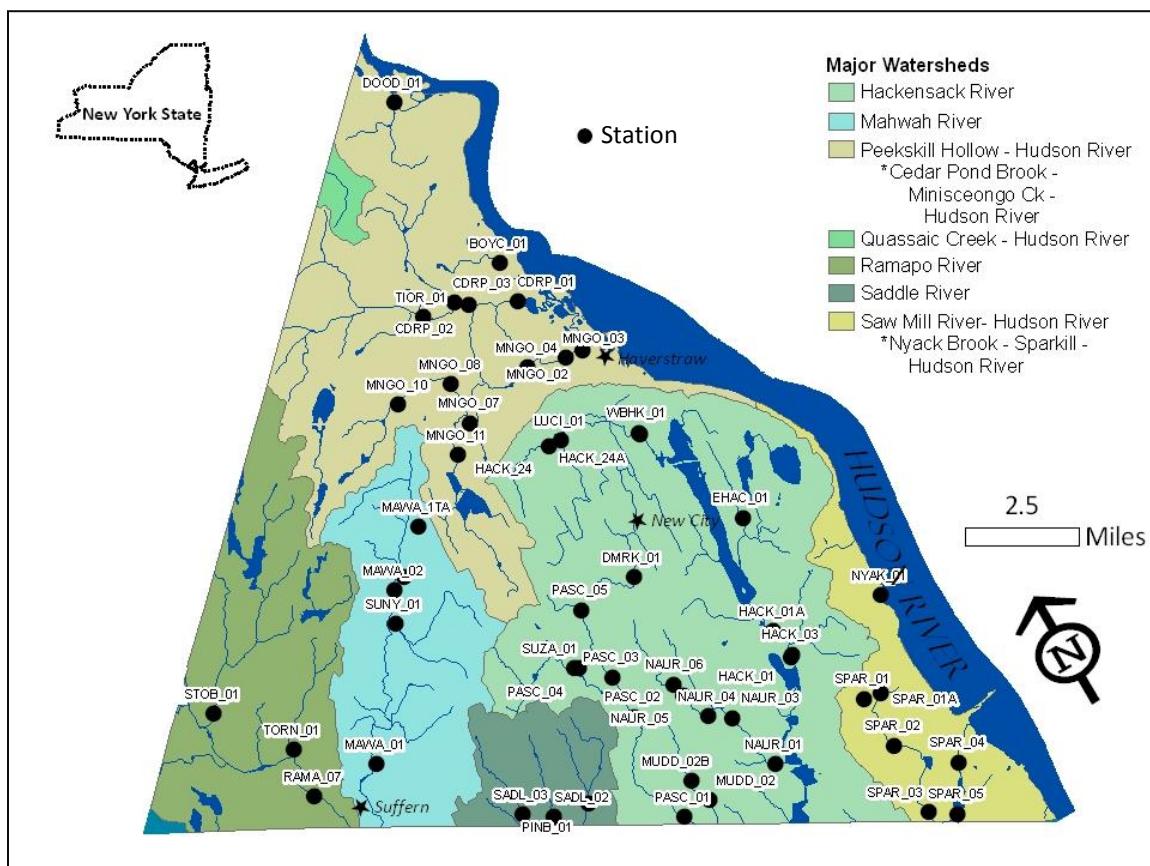
Figure 1. Map of 2006 - 2016 station locations in Rockland County, NY. Watershed delineation and watershed names are based on hydrological drainage units originated by the U.S. Geological Survey New York Water Science Center and U.S Department of Agriculture, New York State Natural Resources Conservation Service (published in 2008). *Indicates the name of the watershed that it is locally known as.

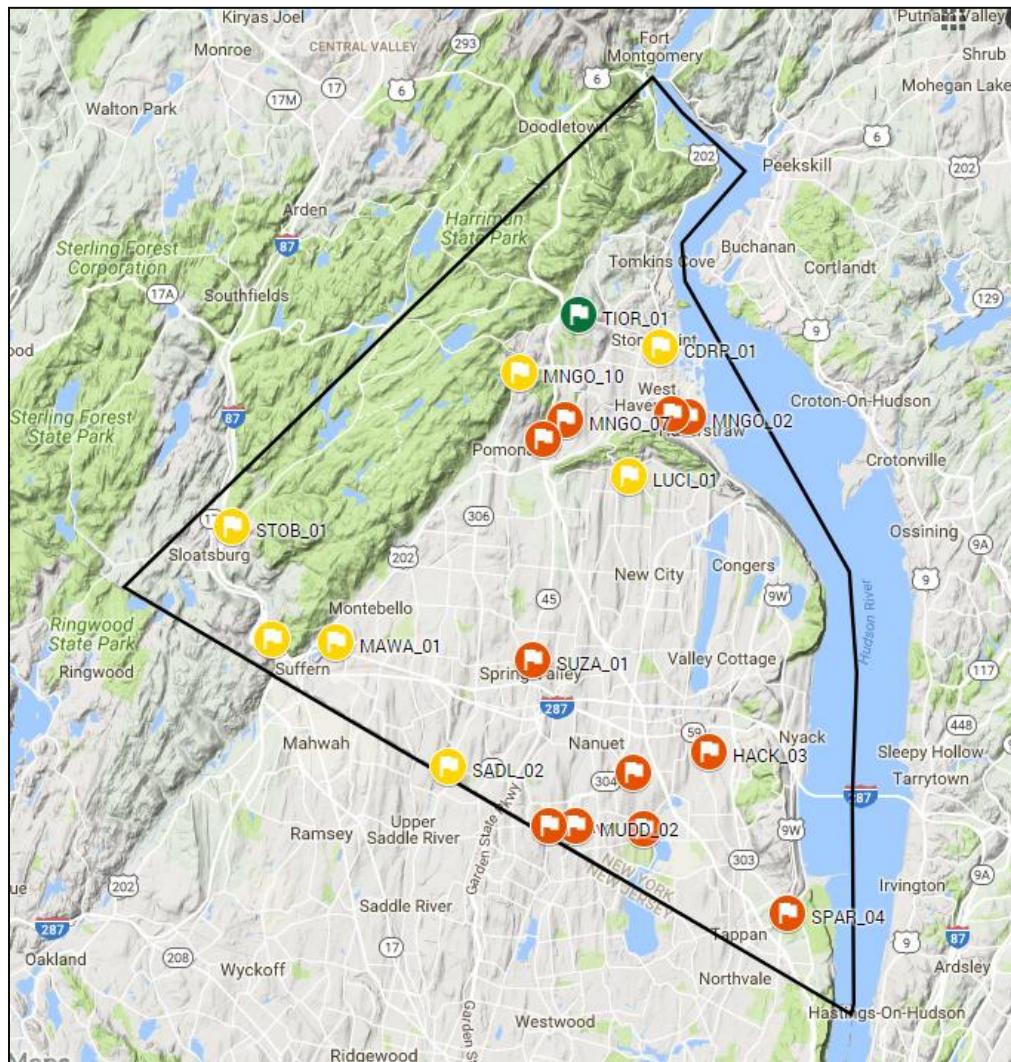
Figure 2. Map of 2016 station locations in Rockland County, NY. Station flag colors of green, yellow, and orange indicate BAP scores equal to non-, slightly, or moderately impacted water quality categories respectively. An interactive map is available to view at this web address:

The 2016 biological community metrics indicated Rockland County water quality ranged from moderately impacted to non impacted: 1 site was non impacted, 7 sites were slightly impacted, and 11 were moderately impacted (Figure 2 and Table 1).

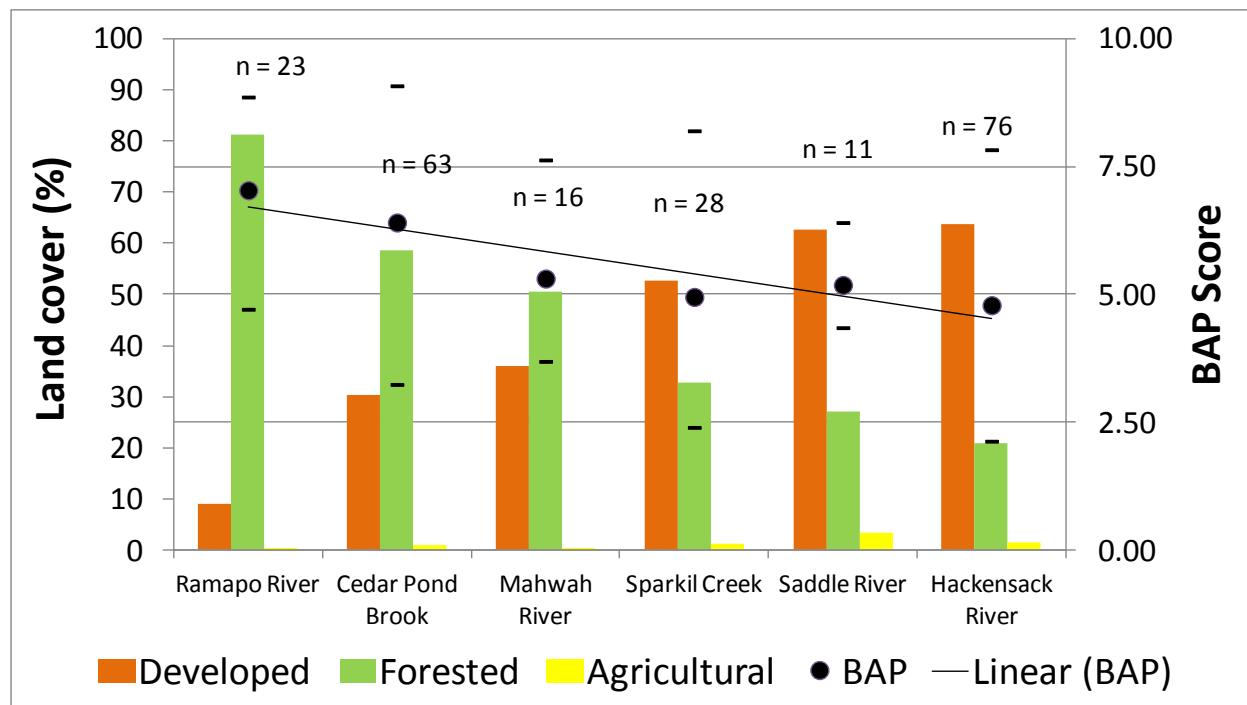
Figure 3. Percentage of land use and mean BAP scores for years 2006 – 2016 within each major watershed. N = number of samples, dashed line indicates minimum and maximum scores.

Since 2006, areas of Rockland County with a higher percentage of forested land have exhibited higher water quality scores than areas of considerable urban development or agriculture (figure 3). Forested areas usually contain fewer sources of pollutants and superior ability to buffer impacts; pollutants are removed from the water as it filters through the soil. The overall impact from agricultural and urban areas is dependent on numerous variables, including the amount of land dedicated to these uses, the volume of impervious surfaces, type and abundance of industry, abundance of automobiles, and management practices.
