Muddy Creek

Margaret Keahon Drive Road Culvert

Application of Stream Biological Impairment Criteria

Report Date: June 2020

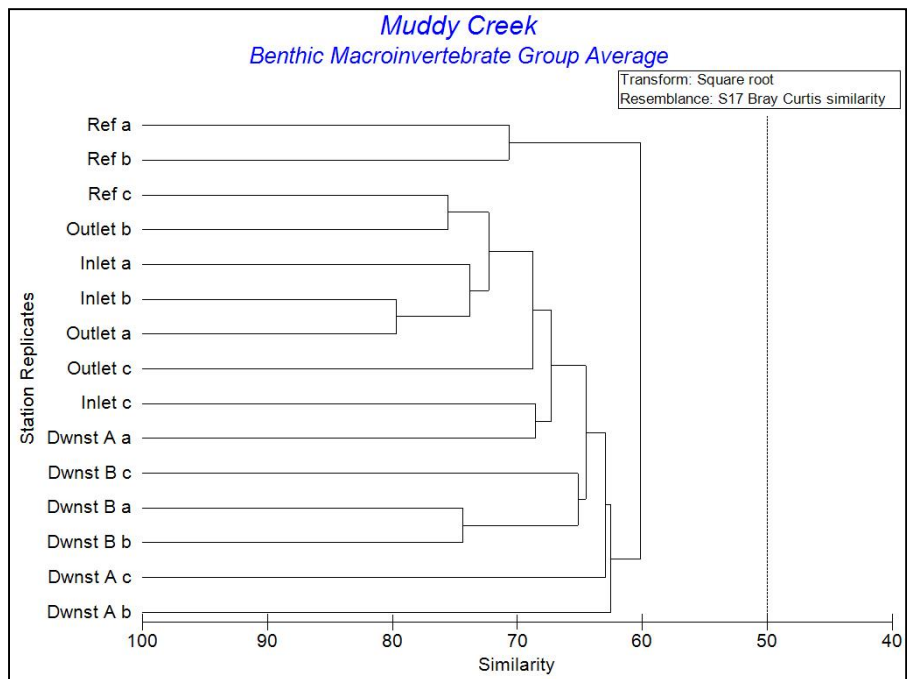
Similarity analysis results between replicate samples met the required $\geq 50\%$ similarity for replicates per station (Figures 2a and 3a) and therefore the first 3 replicates (a, b, c) were used in the analysis.

The Reference community structure was similar to all the stations located downstream (Inlet, Outlet, Downstream A and B). The Bray Curtis similarity (Figures 2 a and b) provides a visual of the community similarity and grouping between these stations. The community at the Reference station appears to be already degraded in water quality based on the community structure. Biological impairment is not indicated at the Inlet, Outlet, and Downstream A & B stations based on EPT richness, biotic index, taxa richness, and percent model affinity metrics (Table 3).

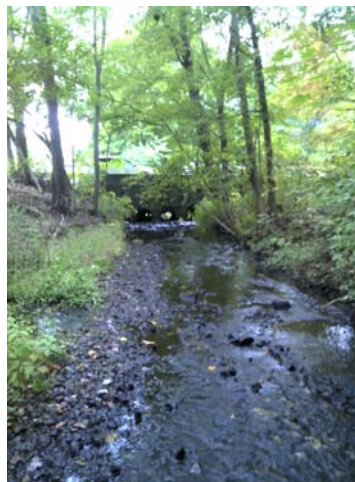
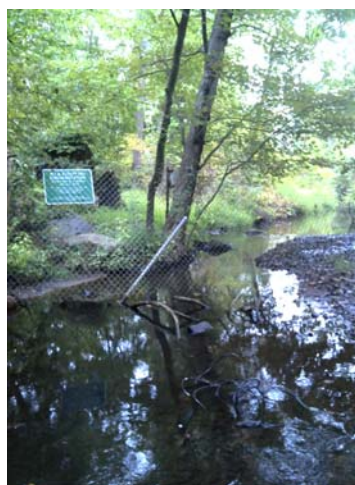
At Gate of Pfizer Property line- was not granted permission to access iste. The kick samples had an bundance of worms in sample; odor in stream; 3 samples only as per Alene Onion, NYS DEC recommendation and closeness to Inlet sample.

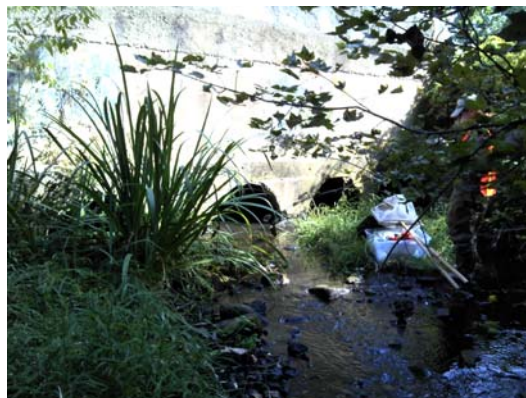
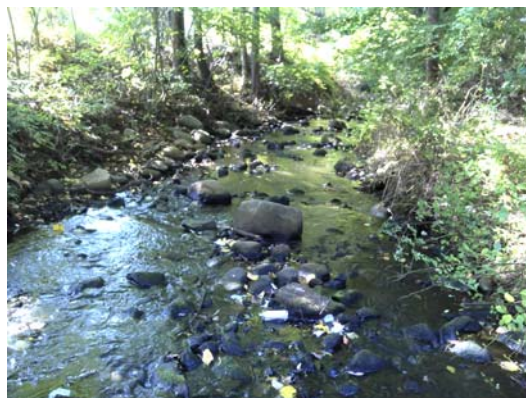
Notes/observations::
 Small sediment bar in the middle of the stream which split the wetted width, added the two sections together, as it was only in one section.
