CASE STUDY: HAVERSTRAW BAY PARK

The Hudson River Sustainable Shorelines Project is a multi-year effort lead by the New York State Department of Environmental Conservation Hudson River National Estuarine Research Reserve, in cooperation with the Greenway Conservancy for the Hudson River Valley.

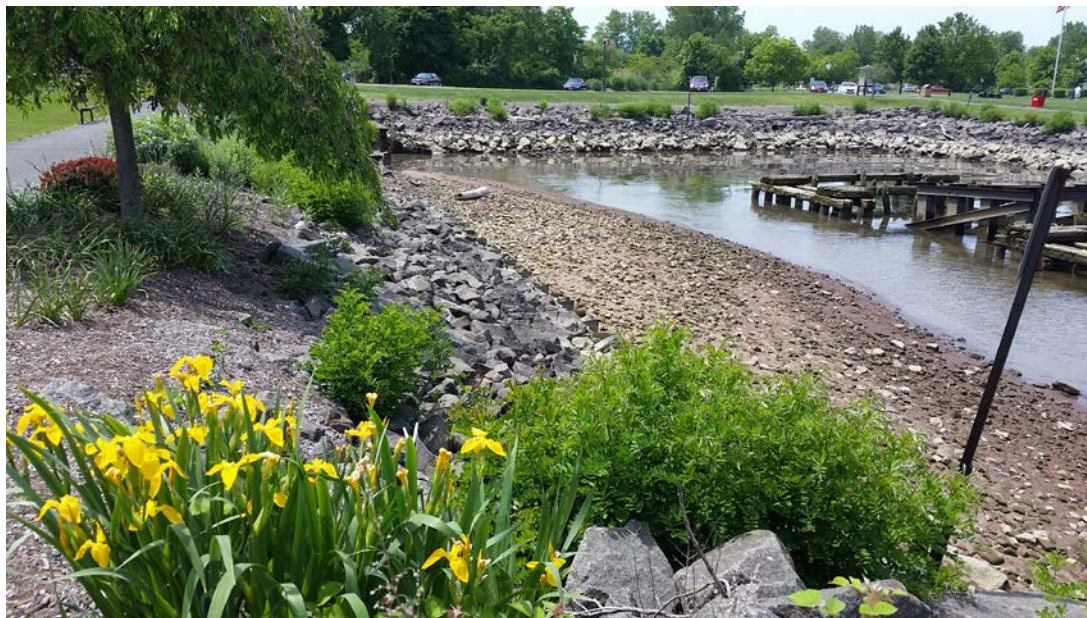
Figure 2. View west from southern embayment at low tide. Yellow flag iris, false indigo and other plantings in the rip-rap. Remnant steel piles from prior industrial activity are visible. Native false indigo shrubs have self-seeded and are cut-back annually.

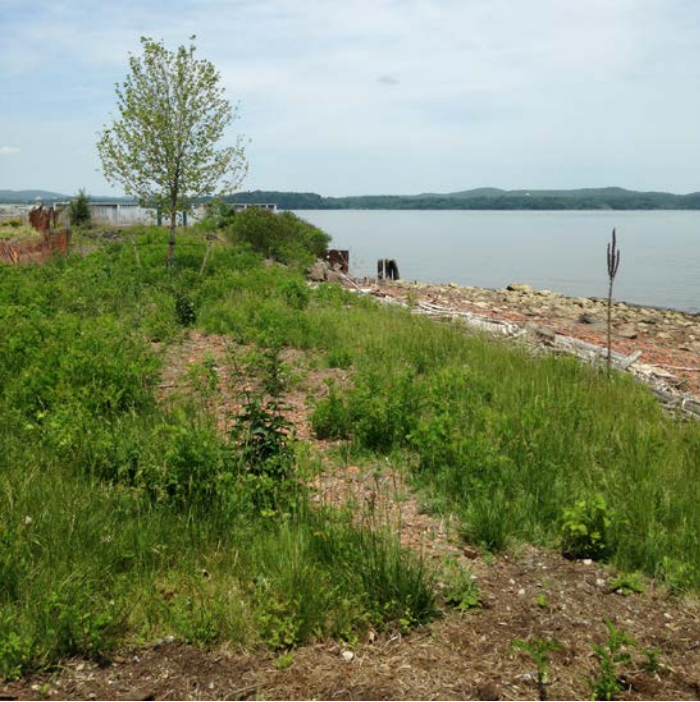
Figure 3. View of north shore zone looking north, with rip-rap, cobble and brick beach, woody debris and vegetated slope.

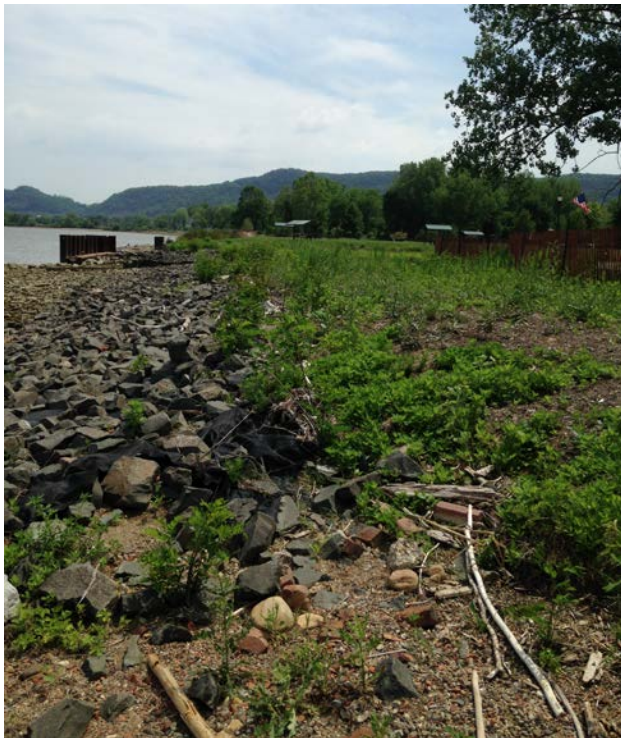
Figure 4. View from northern beach looking to the south. From left to right: displaced rip-rap, wrack line, and transition zone between native planting buffer (not yet planted for this year in early summer 2016). There was some re-grading of this low slope area at the far left where low banks were undercut.

In 2015, the engineering firm McLaren was brought on to design a softer shoreline, per the County’s specifications and needs. Undercut banks caused by erosion were regraded to smooth the slope between the upland and lowland elevations using clean fill, compost, and sand mixture. Both the north and the south beach have low slopes. Native perennials and grasses were interplanted among the existing vegetation along the shoreline (see textbox). Shredded leaf mulch was used as compost around all new plantings. Any exposed synthetic geotextile underlying the original armoring was cut away.

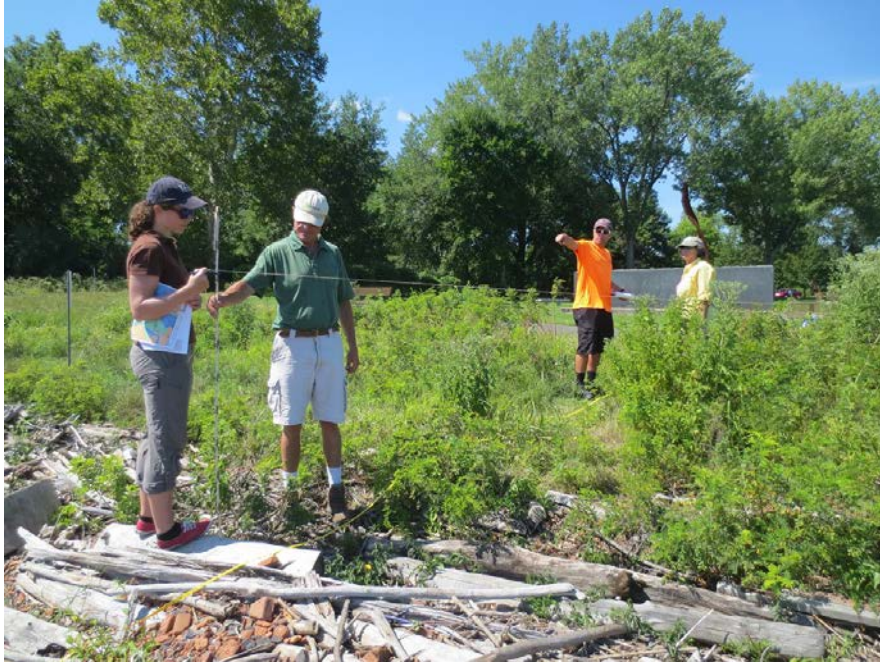
Figure 5. View from southern beach looking west at growing vegetation in the late summer. Wrack-line with large woody debris and brick cobbles visible.
