**MS4 Annual Report Cover Page**

Sparkill Creek MST Study Report (December 1, 2021)

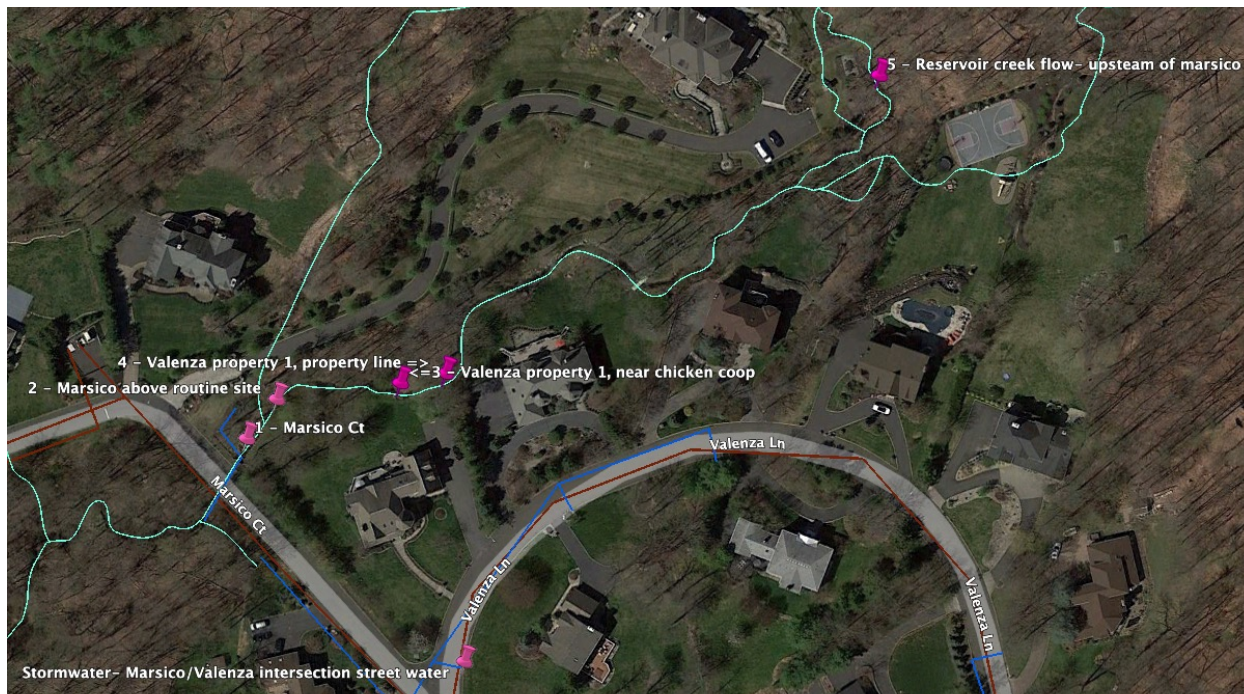
Figure 1: Aerial view of Marsico Court Sampling Area

From 2016 Google Earth image. GPS locations determined from Google Earth.

Eleven new samples, on three sampling dates in 2021, were analyzed in the upper watershed near Marsico Court (Table 2; Figure 1). All 2021 sampling was conducted following significant precipitation because that was the condition in which the highest detection occurred in 2020 sampling. The first sampling for 2021 occurred on 6/4/21 and included samples at the routine monitoring site adjacent to Marsico Court and upstream where a nearby reservoir feeds the creek and was expected to be above most likely sources of human contamination or at least just upstream of currently occupied residential neighborhoods. On this sampling date (6/4/21, light green in Table 2) there was a quantifiable human signal detected at the creek site adjacent to Marsico Court, but no human signal detected upstream where the reservoir feeds into the creek. This result matched expectations based on 2020 MST sampling. The enterococci levels on this date were typical for a wet weather day at the routine Marsico monitoring site and decreased upstream near the reservoir. Site 1 has a series of small input pipes, thought to be stormwater, entering the creek that might contribute to the human signal. There is a nearby sewer pump station and there are houses bordering the creek between sites 1 and 5. To follow up on this initial 2021 sampling, additional sites were added between sites 1 and 5 for the next sampling (8/19/21, light blue in table 2) in an attempt to determine if the human signal could be detected above the routine monitoring site, and in an attempt to constrain the spatial location of possible inputs. August 19 received heavy rainfall (4" or more overnight in Tappan) and the creek was unusually turbid on this day. The enterococci FIB signal on 8/19 was much higher than on the prior (6/4) event, reaching maximum FIB levels (>24,196/100ml) for the dilution used at all four locations. In contrast to the prior wet weather sampling events, human signal was not detected

A final wet weather sampling event was conducted on 10/26/21 (light aqua in table 2) in an effort to better constrain the potential human inputs to this area. Five sites were sampled during another major rain event (at least 5/8" prior to and continuing through sampling), in this case including substantial roadway and backyard flooding. FIB levels were again near maximum detection and in human signal was detectable at all five locations (quantifiable at sites 1 and 3). Unlike the prior sampling events, human contamination was detected even at the most upstream site - complicating the interpretation of these results. It is possible that the extreme precipitation and surface flooding may have altered flow paths creating detectable human signal even at the most upstream location, but it is also possible that some rarely detected human source enters the creek near the reservoir. In combination the 2020 and 2021 sampling demonstrate a strong case for human fecal inputs near Marsico Court despite the relatively low density of development. This signal is most common between sites 1 and 3. Additional management attention to consider the possible presence of septic connections or influence from the nearby pumping station seem appropriate in this area, as the number of possible sources would seem to be quite limited.

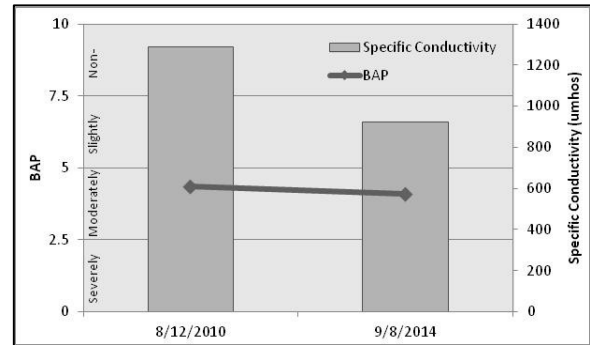
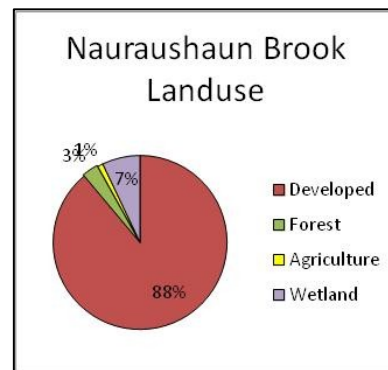
## Nauraushaun Brook

The Nauraushaun Brook study area is 2.46 square miles. In the northern part of the watershed there are large residential developments. The lawns appear to be typically maintained with fertilizers and pesticides/herbicides. The headwater, on a dead end road above I-287, is choked with knotweed and Phragmites and appeared to be dry. South of the interstate, the brook exits a wetland of mostly invasive knotweed and Phragmites and there is a growth of orange colored scum on the rocks just before it enters a tunnel going under the parking lot of Rockland Plaza. Rockland Plaza and The Shops at Nanuet both contribute a large amount of surface runoff to this portion of the stream. Where the stream exits the tunnel (NAUR-06) there is no longer evidence of the orange scum. In this area, there is an existing grass swale for storm water management on a property adjacent to the stream.

A separate tributary to the brook included the Palmer site, located in a residential area and without any gross visual impacts. Downstream from Palmer, two abandoned 55 gallon barrels of used cooking oil were present at N. Middleton Road S1. Further downstream, the Middleton Road S2 site was notable for an oily sheen on the water and soil surface. The riparian area here was flooded, most likely due to an inadequately sized downstream culvert, and the trees in this area are at risk for drowning. Several of these trees have been tagged for an unknown reason. The site was also notable for abundant litter, including an entire case of Styrofoam food trays.

Past the confluence of the tributary with Nauraushaun Brook, the E. Rte 56 & N. Middletown Road site is in a small park with good riparian habitat and no gross litter or debris.

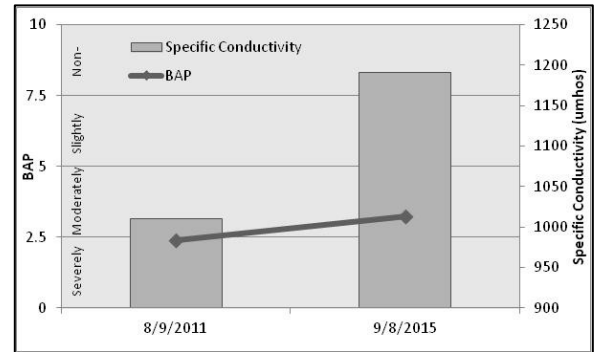
## Nyack Brook

Nyack Brook is a small watershed of less than half a square mile. Because the watershed is small, even minor impacts can significantly alter the health of the brook. The watershed is 96 percent developed, resulting in considerable runoff. Most of the stream runs through a tunnel underneath Nyack.

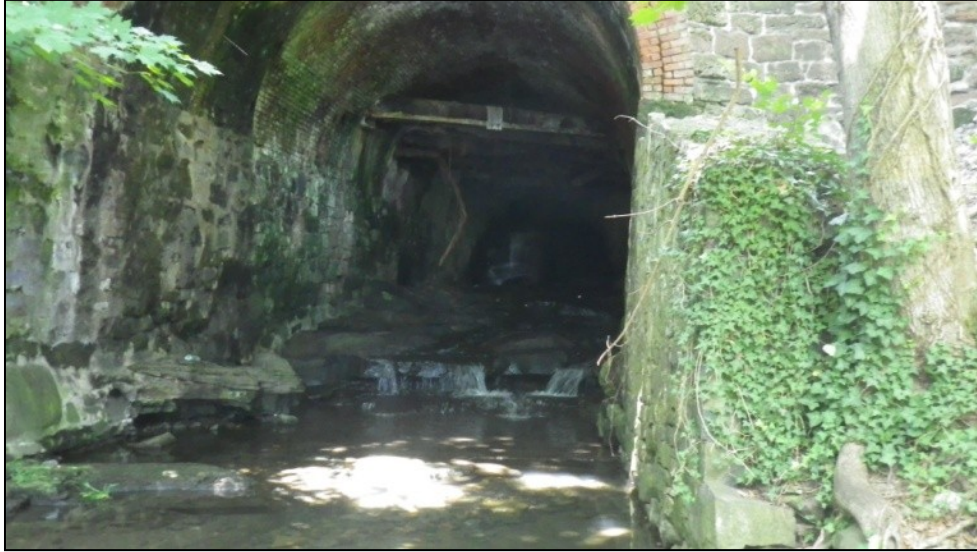
The tunnel that Nyack Brook runs exists from underneath the city. There are drains directly from storm runoff that enter through the ceiling of this tunnel.

The most notable observation at this site is that most of the stream runs underground, affording little sunlight to penetrate the stream, which negatively impacts a waterway. Additionally, the brook is in a highly developed area, with an abundance of paved surfaces leading to runoff into the stream (including through pipes entering the underground portion of the stream). The brook emerges from its underground stretch at a park near the confluence with the Hudson River. Although there are swaths of mowed grass that abut the stream, there are also sections of good riparian habitat and canopy cover here.

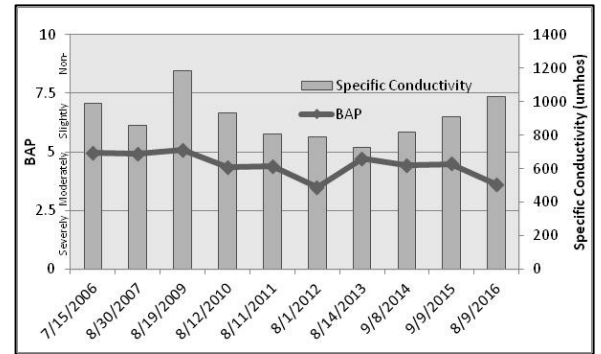
## Muddy Creek

The Muddy Creek Watershed, located upstream from the observation site, is fairly small at 1.62 square miles in area. Sixty percent of the watershed is developed and 26 percent is forested. In the developed areas there is a proliferation of invasive Japanese knotweed. There is an SPDES discharge point within the watershed.

The Convent Road site is a wetland headwater notable for an abundance of invasive Phragmites. The Pasteur Road site is located at the Pfizer Pharmaceutical Offices, which holds an SPDES permit. The site could not be accessed; if this location is included in future evaluations, approval by Pfizer to access the area prior to the day of the evaluation will be required. Margaret Keahon Drive is located below the SPDES permit area. Yard waste dumped into the stream was readily visible here. At Crooked Hill Road, good stream habitat conditions with adequate riparian zones and canopy cover and no gross human impact were observed. The Walter Street Site was notable for the storage of an outdoor drum with no containment system. At the W. Washington Avenue site, there are business downspouts that divert water into the parking lot, then directly into the creek.

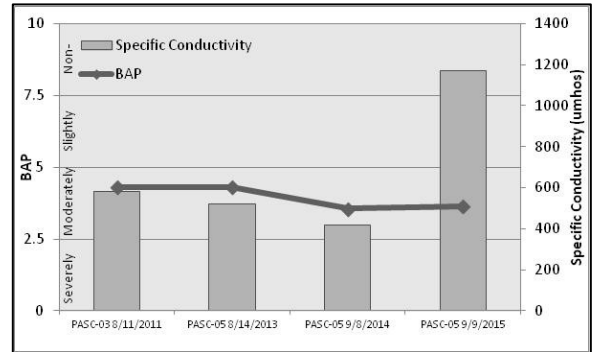
## Pascack Brook

Pascack Brook watershed is 3.33 square miles in area north of the bottom most site, PASC-03. PASC-05 is about halfway between PASC-03 and the northernmost part of the watershed. 86% of the land use is developed, and the majority of that is residential. The stream is artificially straightened, or channelized, through most of these neighborhoods. There is very little riparian area, with a few trees but mostly mowed grass right up to the stream bank. The loss of the riparian buffer and channelization of the stream is contributing to erosion. In several spots there are storm water discharge points which can increase flows and contribute to pollution.

Greenridge Way is in a residential area, but there are no obvious human impacts at this stretch of the brook. At Bristol Lane the stream is underground and homes are located directly above the culvert; diminished sun exposure at this stretch has the potential to affect stream biota. The site off N. Main Street is notable for lack of canopy cover over the stream and a retention pond. The Innington Court

site is located in a residential area notable for well-manicured monoculture lawns, indicating the use of herbicides and pesticides that can contaminate runoff. Additionally, there is litter and yard waste being dumped onto the stream banks. At the Dwight Avenue site the brook has been channelized and enters the yards of a residential neighborhood. A “no dumping” sign had been erected at the Inwood Drive site; nevertheless, yard waste is being disposed of here. The brook is turbid at the Mirror Lake Road site and there was an abundance of litter here. There were several storage drums with no containment system at the site just off North Pascack Road. Water at the North Pascack Road site is turbid; there are areas of runoff upstream from the site.

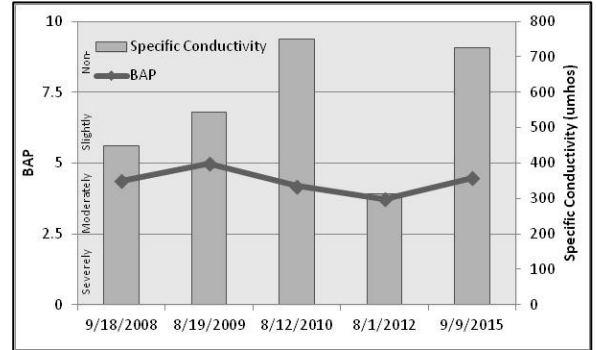
## Pine Brook

The watershed to this brook is 2.23 square miles in area. The headwaters are near a large sports field that is most likely treated with fertilizer and herbicides. The headwater of the western branch of the brook contains an old small dam at Jon Leif Lane that is choked with litter and debris. The brook mostly traverses a residential area with mowed lawns, some to the bank of the stream. There is at least one large dam on the main branch of the brook.

At Dykstras Wey E. the area is strewn with litter, including along the stream banks, and the storm drains are clogged with both litter and debris. At Jon Leif Lane there is an old dam that empties into a culvert. Water behind the dam is stagnant and has breached the stream banks, resulting in a large wooded area of water and mud. It is littered with debris that probably originates from the upstream community. The dam drains through a small pipe into a culvert which itself may be too small to hold the upstream water during times of high flow. The Fellowship Community Park site abuts a parking lot that appears to drain

its runoff directly into the stream through a pipe. The stream runs through a swale of mowed grass with no riparian cover. The Hungry Hollow site is on a branch tributary to the stream that runs past a day camp with swimming area. Past the confluence of this tributary with Pine Brook, the Capricorn Lane site is notable for generalized litter and a sinkhole in the road next to a culvert. The Capital Park site is notable for litter and yard waste.

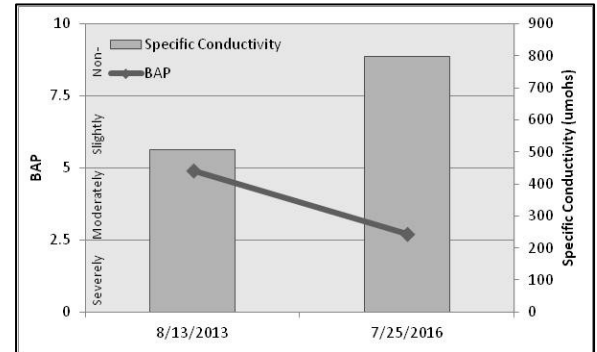
## Minisceongo Creek

Of the 5.26 square miles of watershed upstream of MNGO-11, half is developed, 49% is split between forest and wetland, and 1% percent is agricultural. The watershed contains two golf courses, including one with a ponded area created by construction of a dam along the stream. In several neighborhood locations, there is channelization of the creek.

At Sandy Brook Town Park there is a heavily silted pond with no riparian cover. There is an aeration system in the pond at Pomona Road, but heavy algae growth is also present, indicating high levels of nutrients in the water body. A good riffle habitat is present along the stretch at Camp Hill Road. At Route 202 Plaza, a parking lot abuts the brook, there is no adjoining retention basin to curtail runoff and there is very little riparian cover. The Quaker Road Mobile Home Park site is notable for an abundance of litter and yard waste. Across the stream at this location there is a tree service that has deposited logs within a couple of meters from the stream. The Woodfield Road site is notable for an abundance of

Japanese knotweed and lawn clippings. The Burgess Meredith Park site is notable for good habitat and riparian cover.

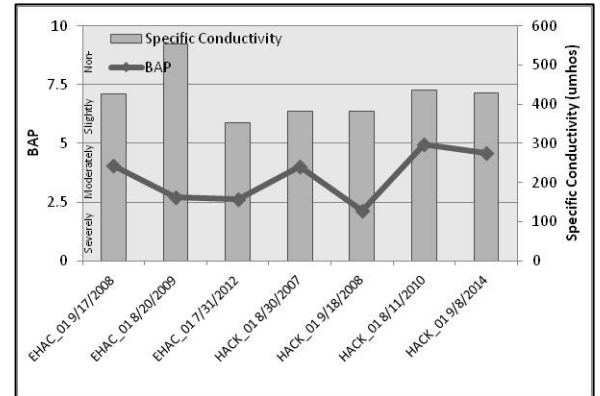
## Hackensack River

At 34.61 square miles, this was the largest watershed in the study, and included two of the most impacted sites (HACK-01 and EHAC-01). A dammed portion of the Hackensack creates Lake DeForest Lake, a reservoir for local residents. Other land use includes: 56% developed, 26% forest, 10% wetland and 2% agriculture. The watershed comprises golf courses, dams (both large and small backyard dams), quarries and parks, and three SPDES discharge sites, including two at quarries or rock processing facilities and the one at the outlet of Lake DeForest.

Gilchrest Road and the banks are littered with yard brush. Svahn Drive is notable for a thin strip of riparian habitat, and the storm drains have been stenciled to educate against dumping of trash.

There is a large dam at Old Mill Road that is part of DeForest Lake. Past the lake and a quarry, in a mixed residential and commercial area, there is a retaining pond adjacent to the stream at Louis Drive that contains a water pump. Downstream from this site at Western Highway W, the streambank is strewn with litter, there is a lack of riparian habitat, the stream is turbid and sluggish and there is an abundance of algae and invasive species.

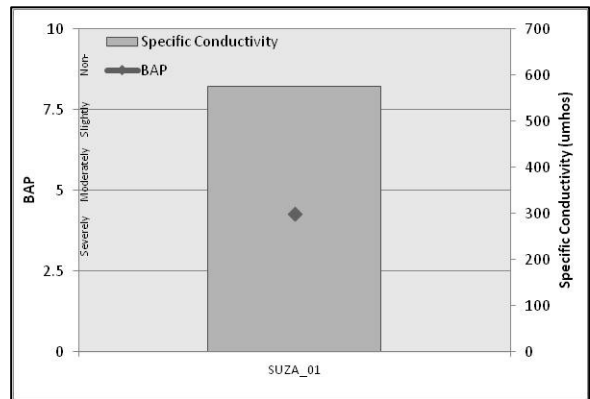
## Tributary to Pascack Brook (SUZA\_01)

This 3.66 square mile watershed is 92% developed, mostly with homes and community centers; there are also numerous new construction projects. The watershed includes Suzanne Lake, which is a catch basin for construction sediment runoff and litter from the surrounding community.

At Lenore Avenue, in a residential area, there is piled dirt and gravel near the stream bank on a lot sited for construction. Good flow, fair stream habitat and adequate riparian cover is present at Suzanne Drive and Francis Place. Further along Suzanne Drive, there is a pond with heavy siltation and turbidity; the pond is strewn with litter. Of note is that we observed the Town of Ramapo Litter Patrol truck in this area; workers advised us that they are unable to keep up with removal of the litter here. At Suzanne Pond dam there was an abundance of litter and food waste. Francis Place and Morris Road were notable for construction debris in the stream and lack of silt fences. The SUSA tributary retention basin at Francis Place is heavily silted and it's unclear whether the basin is functioning correctly. The W. Eckerson Road site, an upper SUSA headwater tributary is just below a golf course (with potential
